**Flood Control Project Maintenance
Levee Inspections**

Maintenance Issue Types Only, Levee Inspection Report By Mile - Spring 2017

Reclamation District No. 2068 Yolo

Waterway	Bank	Unit Miles	Inspection Start/End	Inspector
Unit No. 01 Yolo Bypass	Right	5.48	04/25/2017 04/25/2017	Herman Phillips

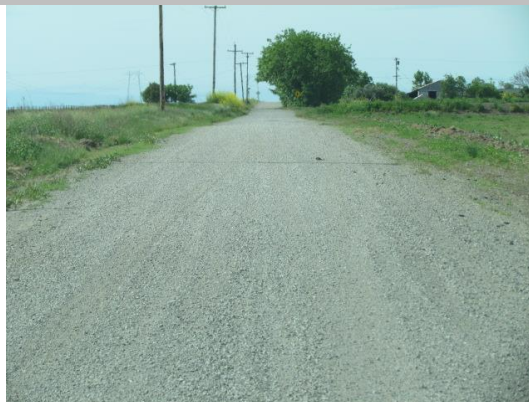
Photo 1 of 1 : SP_2017_RD2068_193_14_20170518_00015.jpg

LM Start	0.06	Rating **	A	Issue No.	14
LM End	0.45	Issue Type +	Ma	Location *	LS
Category	Earthen Levee			GPS Latitude/Longitude	
				Start	End
Item	Vegetation			38.407740 °	38.402073 °
				-121.693763 °	-121.693780 °
DWR ID	DWR_RD2068_01_s_2017_14				
Comment Code					
V1 : Control annual grass and weeds on the levee slopes and easements.					
Inspector Comment					
No unwanted vegetation on landside slope from 0.06 to 0.45.

RD 2068 Looking downstream from levee mile 0.06 landside.

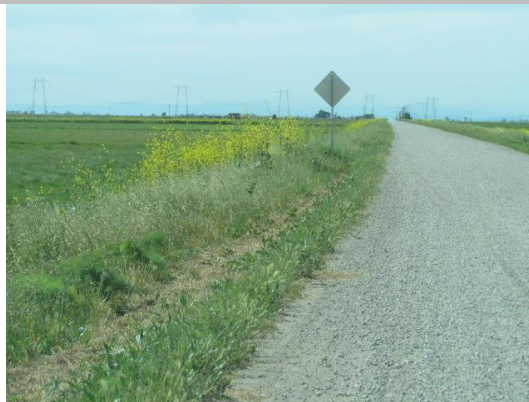
Photo 1 of 1 : SP_2017_RD2068_193_13_20170518_00016.jpg

LM Start	0.06	Rating **	M	Issue No.	13
LM End	0.50	Issue Type +	Ma	Location *	WS
Category	Earthen Levee			GPS Latitude/Longitude	
				Start	End
Item	Vegetation			38.407740 °	38.401318 °
				-121.693763 °	-121.693790 °
DWR ID	DWR_RD2068_01_s_2017_13				
Comment Code					
V1 : Control annual grass and weeds on the levee slopes and easements.					
Inspector Comment					
Control the annual grasses and weeds on the slope and toe.

Looking downstream from levee mile 0.06 landside shoulder.

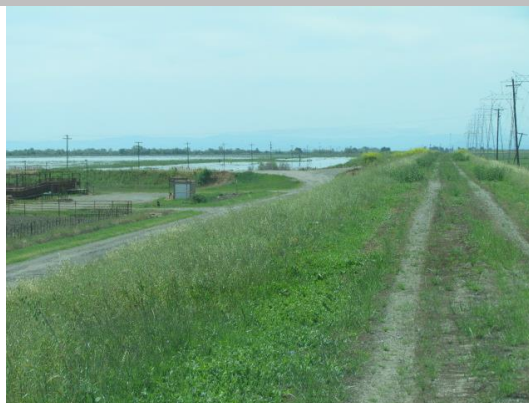
Photo 1 of 1 : SP_2017_RD2068_193_16_20170518_00017.jpg

LM Start	0.50	Rating **	U	Issue No.	16
LM End	5.48	Issue Type +	Ma	Location *	WS
Category	Earthen Levee			GPS Latitude/Longitude	
				Start	End
Item	Vegetation			38.401318 °	38.329110 °
				-121.693790 °	-121.694093 °
DWR ID	DWR_RD2068_01_s_2017_16				
Comment Code					
V1 : Control annual grass and weeds on the levee slopes and easements.					
Inspector Comment					
Control the annual grasses and weeds on the levee slope and toe waterside.

RD 2068 Looking downstream from levee mile 0.50-5.48 tall weeds present on the levee slope.

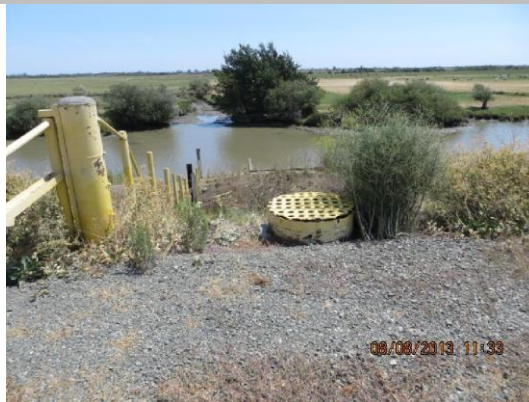
Photo 1 of 3 : UCIP_SP_2017_17479_29574.jpg

LM Start	5.46	Rating **	A/W	Issue No.	32
LM End	5.46	Issue Type +	Ma	Location *	CR
Category	Supplemental			GPS Latitude/Longitude	
				Start	End
Item	DWR UCIP LMA Responsibility			38.329410 °	38.329410 °
				-121.694076 °	-121.694076 °
DWR ID					
Comment Code					
Inspector Comment					
FS_ID:17479 DS_ID:19343 EP_NO: 2359 Repair Type: No Action Needed Crossing Status: Found UCIP Comments: FIELD_STRUCT_DESC: 1 of 2: 36-inch steel drain pipe though the levee 3 feet below the crown. Siphon breaker in 36-inch diameter steel riser on WS shoulder. Flap gate in 10'X20' concrete outlet box at WS toe (Permit No. 2359, 1957). Included in O&M manual, 1962. FS Date: 8/8/2013

Siphon breaker in 36-inch diameter steel riser on WS shoulder.

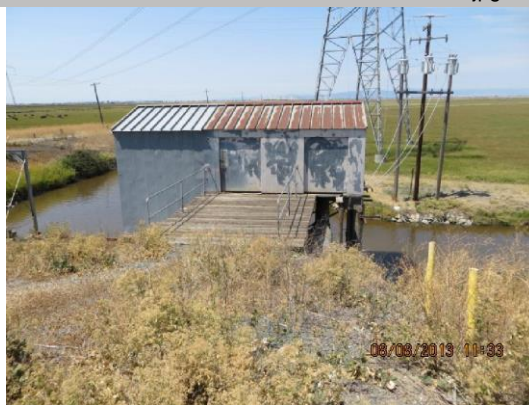
Photo 2 of 3 : UCIP_SP_2017_17479_29573.jpg

Pumphouse visible on pier at LS.

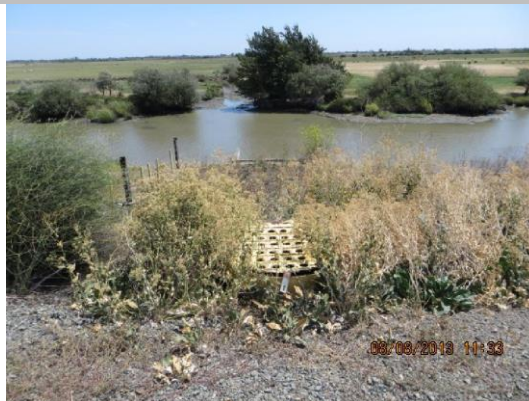
Photo 2 of 3 : UCIP_SP_2017_17480_29577.jpg

LM Start	5.46	Rating **	A/W	Issue No.	33 (cont)
LM End	5.46	Issue Type +	Ma	Location *	CR
Category	Supplemental			GPS Latitude/Longitude	
				Start	End
Item	DWR UCIP LMA Responsibility			38.329397 °	38.329397 °
				-121.694076 °	-121.694076 °
DWR ID					
Comment Code					
Inspector Comment					
FS_ID:17480					
DS_ID:19342					
EP_NO: 2359					
Repair Type: No Action Needed					
Crossing Status: Found					
UCIP Comments:					
FIELD_STRUCT_DESC: 2 of 2: 42-inch steel drain pipe though the levee 3 feet below the crown. Siphon breaker in 36-inch steel riser on WS shoulder. Flap gate in 10'X20' concrete outlet box at WS toe. Pump in pumphouse on pier at LS (Permit No. 2359, 1957). Included in O&M manual, 1962.					
FS Date: 8/8/2013

Siphon breaker in 36-inch steel riser on WS shoulder.

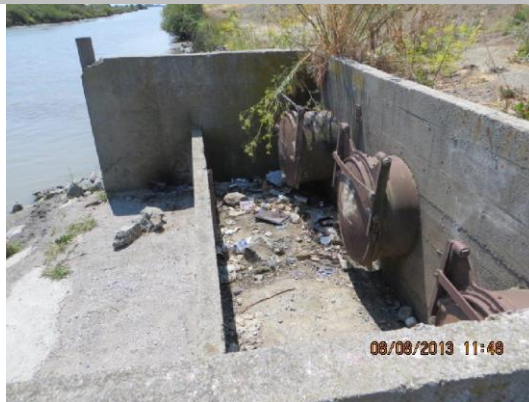
Photo 3 of 3 : UCIP_SP_2017_17480_29576.jpg

Flap gate in 10'X20' concrete outlet box at WS toe.

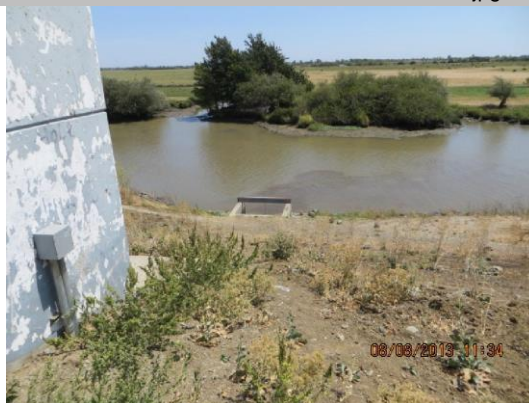
Photo 3 of 3 : UCIP_SP_2017_17503_29585.jpg

LM Start	5.47	Rating **	A/W	Issue No.	34 (cont)	
LM End	5.47	Issue Type +	Ma	Location *	CR	
Category	Supplemental			GPS Latitude/Longitude		
				Start		End
Item	DWR UCIP LMA Responsibility			38.329275 °	38.329275 °	
				-121.694078 °	-121.694078 °	
DWR ID						
Comment Code						
Inspector Comment						
FS_ID:17503						
DS_ID:19340						
EP_NO: 15923						
Repair Type: No Action Needed						
Crossing Status: Found						
UCIP Comments:						
FIELD_STRUCT_DESC: 6'x6' Reinforced concrete box culvert through the levee 21.1 feet below the crown. 9'X14' concrete inlet/weir on LS toe. 7'X10' concrete building houses Slide gate on WS shoulder Flap gate in 8'X10' concrete U-shaped headwall on WS toe. (Permit No. 15923, 1992). Culvert replaced three 36-inch pipes installed under Permit No. 10160, 1974.						
FS Date: 8/8/2013

Flap gate in concrete outlet on WS toe.

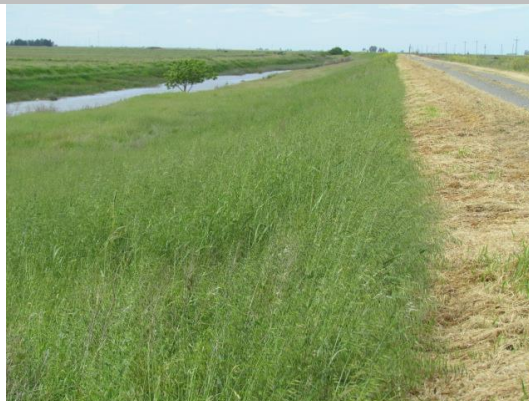
Photo 1 of 1 : SP_2017_RD2068_194_10_20170518_00008.jpg

LM Start	0.01	Rating **	U	Issue No.	10
LM End	0.93	Issue Type +	Ma	Location *	LS
Category	Earthen Levee			GPS Latitude/Longitude	
				Start	End
Item	Vegetation			38.358227 °	38.371688 °
				-121.740365 °	-121.740033 °
DWR ID	DWR_RD2068_02_s_2017_10				
Comment Code					
V1 : Control annual grass and weeds on the levee slopes and easements.					
Inspector Comment					
Control the annual grasses and weeds on the landside slope and berm.

RD 2068 Looking downstream landside slope and berm.

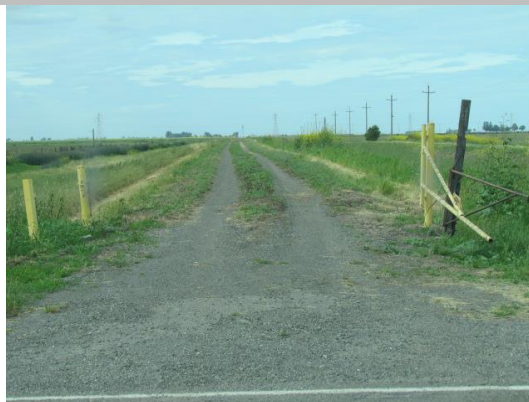
Photo 1 of 1 : SP_2017_RD2068_194_11_20170518_00009.jpg

LM Start	0.01	Rating **	M	Issue No.	11
LM End	1.85	Issue Type +	Ma	Location *	CR
Category	Earthen Levee			GPS Latitude/Longitude	
				Start	End
Item	Vegetation			38.358313 °	38.382542 °
				-121.740385 °	-121.730262 °
DWR ID	DWR_RD2068_02_s_2017_11				
Comment Code					
V9 : Keep the crown roadway free of vegetation.					
Inspector Comment					
Keep crown roadway free of vegetation.

RD 2068 Looking downstream from levee mile 0.01.

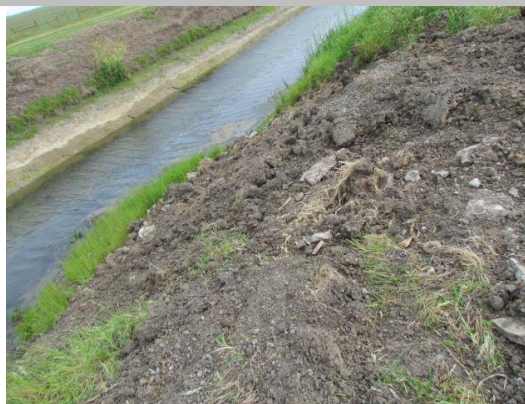
Photo 1 of 1 : SP_2017_RD2068_194_14_20170518_00010.jpg

LM Start	0.65	Rating **	M	Issue No.	14
LM End	0.65	Issue Type +	Ma	Location *	LS
Category	Earthen Levee			GPS Latitude/Longitude	
				Start	End
Item	Slope Stability			38.367547 °	38.367547 °
				-121.740273 °	-121.740273 °
DWR ID	DWR_RD2068_02_s_2017_14				
Comment Code					
S1 : Repair slope instability.					
Inspector Comment					
RD has made repairs to slip.

RD 2068 Slope instability 0.65 waterside slope.

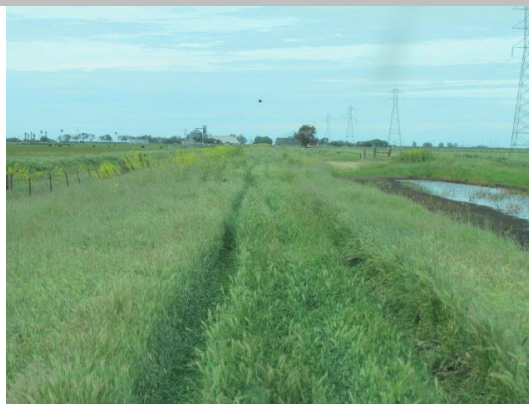
Photo 1 of 2 : SP_2017_RD2068_194_15_20170518_00013.jpg

LM Start	1.85	Rating **	U	Issue No.	15
LM End	2.16	Issue Type +	Ma	Location *	CR
Category	Earthen Levee			GPS Latitude/Longitude	
				Start	End
Item	Vegetation			38.382542 °	38.386237 °
				-121.730262 °	-121.726930 °
DWR ID	DWR_RD2068_02_s_2017_15				
Comment Code					
V9 : Keep the crown roadway free of vegetation.					
Inspector Comment					
Keep crown roadway free of vegetation. Not able to continue from this point crown roadway too soft. Stopped at levee 2.16.

Looking downstream from levee mile 2.16

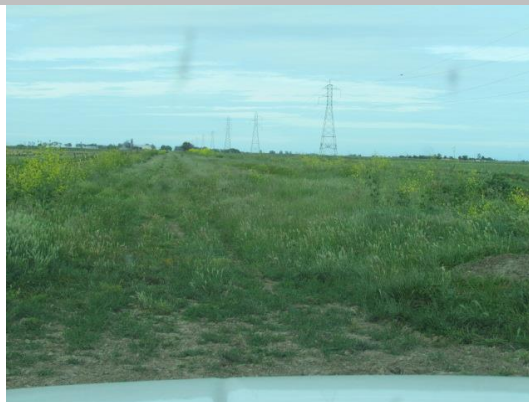
Photo 2 of 2 : SP_2017_RD2068_194_15_20170518_00014.jpg

Looking upstream from levee mile 2.16.

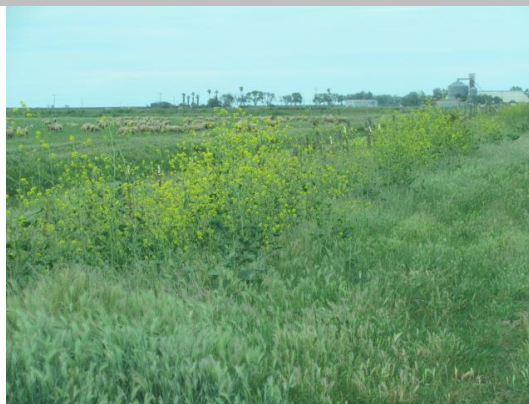
Photo 1 of 1 : SP_2017_RD2068_194_16_20170518_00011.jpg

LM Start	1.85	Rating **	U	Issue No.	16
LM End	2.16	Issue Type +	Ma	Location *	LS
Category	Earthen Levee			GPS Latitude/Longitude	
				Start	End
Item	Vegetation			38.382542 °	38.386237 °
				-121.730262 °	-121.726930 °
DWR ID	DWR_RD2068_02_s_2017_16				
Comment Code					
V1 : Control annual grass and weeds on the levee slopes and easements.					
Inspector Comment					
Control the annual grasses and weeds on the landside slope and toe.

RD 2068 landside slope levee mile 1.85- 2.16.

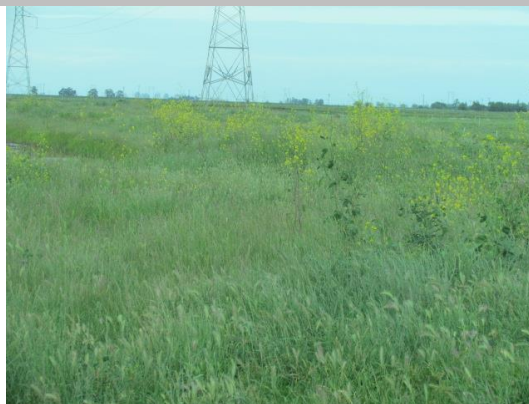
Photo 1 of 1 : SP_2017_RD2068_194_17_20170518_00012.jpg

LM Start	1.85	Rating **	U	Issue No.	17
LM End	2.16	Issue Type +	Ma	Location *	WS
Category	Earthen Levee			GPS Latitude/Longitude	
				Start	End
Item	Vegetation			38.382542 °	38.386237 °
				-121.730262 °	-121.726930 °
DWR ID	DWR_RD2068_02_s_2017_17				
Comment Code					
V1 : Control annual grass and weeds on the levee slopes and easements.					
Inspector Comment					
Control the annual grasses and weeds from the waterside levee slope and toe.

RD 2068 Waterside levee mile 1.85-2.18

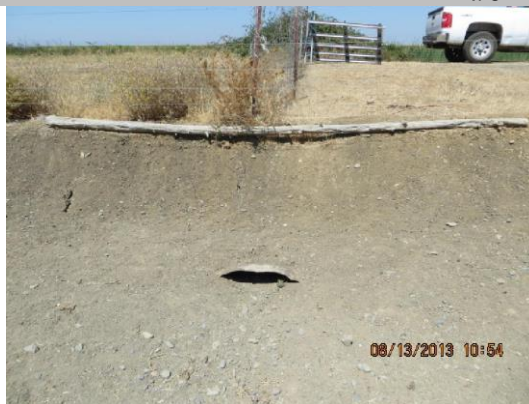
Photo 1 of 1 : UCIP_SP_2017_42725_29680.jpg

LM Start	3.15	Rating **	M	Issue No.	26
LM End	3.15	Issue Type +	Ma	Location *	WS
Category	Supplemental			GPS Latitude/Longitude	
				Start	End
Item	DWR UCIP LMA Responsibility			38.397933 °	38.397933 °
				-121.716406 °	-121.716406 °
DWR ID					
Comment Code					
Inspector Comment					
FS_ID:42725 DS_ID:19352 EP_NO: 10164 Repair Type: Non-Urgent Crossing Status: Found UCIP Comments: Appears abandoned and if so should be done properly. Pipe buried except for small opening. FIELD_STRUCT_DESC: *ABANDONED* 6 of 6: 48-inch corrugated metal pipe through the levee 4.0 feet below the crown (ABO No. 10164, 1974). Originally included in the O&M manual, 1962. FS Date: 8/13/2013

Pipe buried but visible at toe of east side of levee.
